Series 2000 Bill Programming Module (BPM)

The purpose the BPM is to download new software into AE2600 Bill Acceptors and VN2500/AE2400 with MEI FLASHPORT Bill Acceptors. Only VN2500/AE2400's manufactured during or after the 40th week of 1999 have the MEI FLASHPORT capability (see page 4 to determine when the unit was manufactured). All MEI FLASHPORT capable VN2500/AE2400's have the "with MEI FLASHPORT" logo on the product label on the box and on the side of the unit.

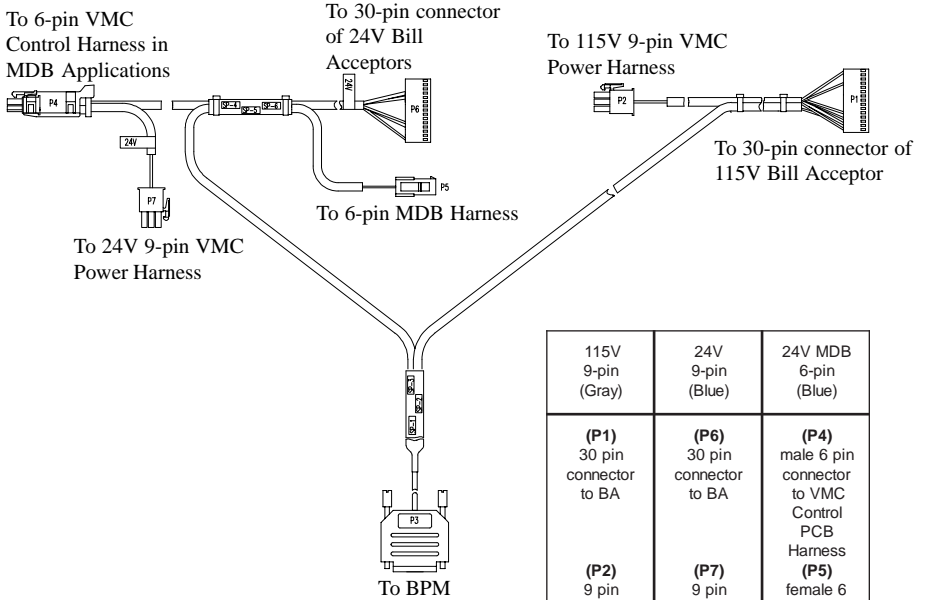
Connections:

115V 9-pin (Gray)	24V 9-pin (Blue)	24V MDB 6-pin (Blue)
(P1) 30 pin connector to BA	(P6) 30 pin connector to BA	(P4) male 6 pin connector to VMC Control PCB Harness (P5) female 6 pin connector to MDB Harness
(P2) 9 pin connector to VMC Power Harness	(P7) 9 pin connector to VMC Power Harness

3. Connect the BPM (See next page), then power up the machine.
4. Once the bill acceptor completes a run and stack, (motors cycle) press the Red Button on the BPM till the Green LED illuminates to indicate power to the BPM.
